MCF5271 Chip Errata

Silicon Revision: All

This document identifies implementation differences between the MCF5270 and MCF5271 processors and the description contained in the *MCF5271 ColdFire® Reference Manual*. Refer to <http://www.freescale.com/coldfire> for the latest updates.

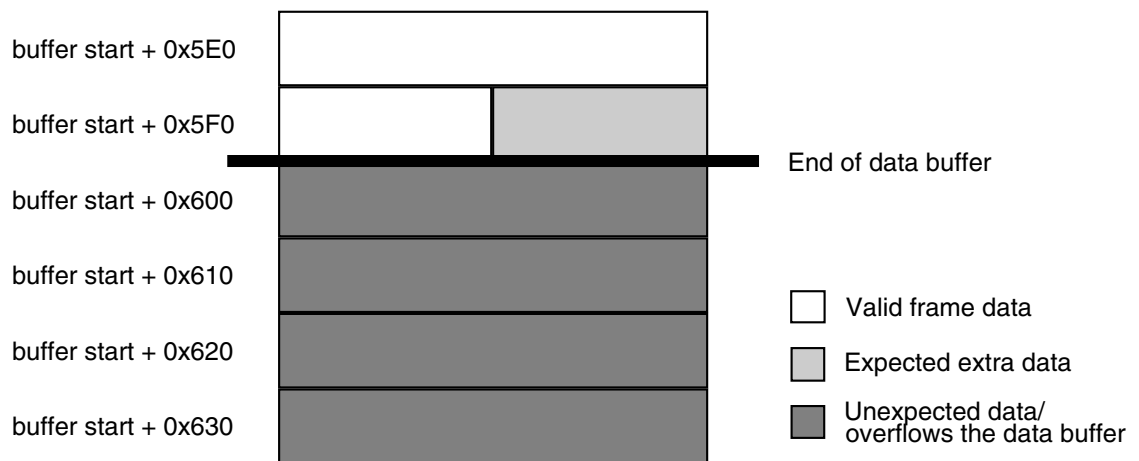
Figure 1. Buffer Overrun Example

Description: When the FEC is connected to a 10BaseT network, if length of the data stored in a descriptor is not evenly divisible by 16 (not line-aligned), the FEC writes extra lines at the end of the buffer. The entire line that contains the last valid data is written and at least one extra line, but up to four lines after the end of the valid data can also be written. In most cases, this is not a problem because the extra lines of data continue falling within the limits of the buffer. However, if the valid data ends near the end of the buffer, the extra lines written by the FEC might be outside of the data buffer. This leads to corruption of the next buffer, descriptor, data, or code stored in the adjacent memory.

For example, as shown in the figure below, if the max buffer size is programmed to 0x600 and a frame that is 0x5F8 bytes long is received, a line is written starting at buffer start + 0x5F0. The first half of the line at buffer start + 0x5F0 is valid frame data that should be processed by the FEC driver; the second half of the line is additional data that is written because the FEC only writes complete lines. This data should be ignored by the FEC driver. So far, this is correct FEC behavior as originally specified. However, the FEC repeats the last line of valid data a number of times. The line at buffer start + 0x600 is written, and as many as three additional lines beyond the end of the data buffer could be written.

Workaround: Only use 100BaseT.

Workaround: Allocate extra lines for the receive data buffers. The actual allocated memory for each buffer should be equal to the receive buffer size programmed in the FEC's EMRBR register plus four lines (16 byte-sized lines).

Workaround: Program the data buffer size one line larger than the max packet size (data buffer size = EMRBR + 0x40).
